Manhole Inspection Summary

Manhole # S09KK1016MH

Insp Date: **5/16/07 1:13 PM**

Location Address: **3525 LUCILLE AVE**

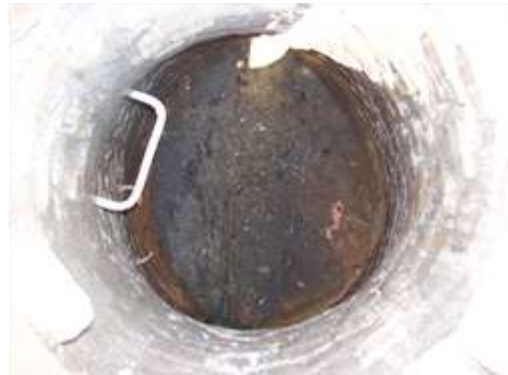
Top View

Count: **2** Missing: **1** ☐ Corroded

MISSING 1 STEP

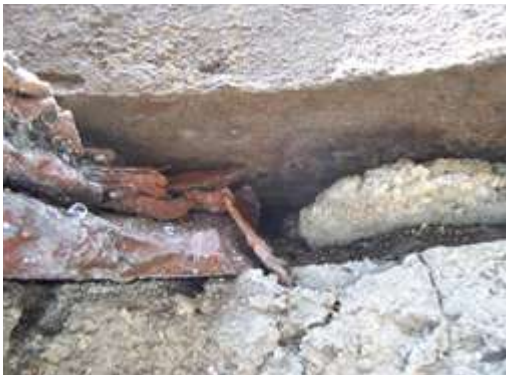
Defect 2

Condition: ☐ Sound ☐ Cracked ☐ Root Intrusion ☒ **Loose Brick** ☒ **Deteriorated**

FRAME SEAL DETERIORATING

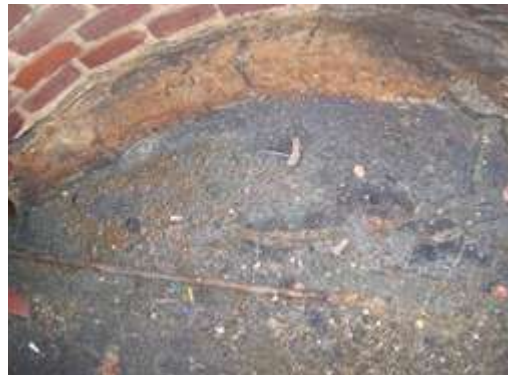
Defect 1

SUMMIT MANHOLE WITH DEBRIS

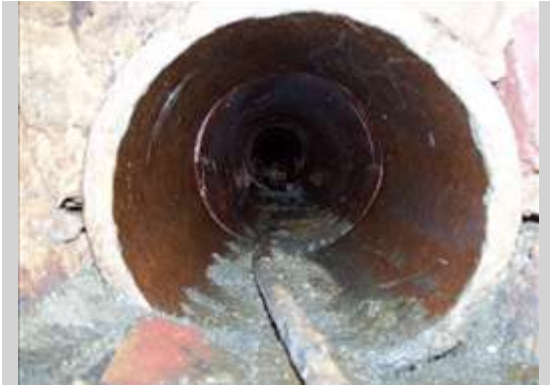
12 O'Clock Outflow

Deposits: ☐ None ☐ Mud ☐ Sludge ☒ **Debris** ☐ Grease

Silt Depth: **1** (in.) Deposits Extent: **Medium**

Infiltration: **None** Pipe Seal Cond: **Broken**

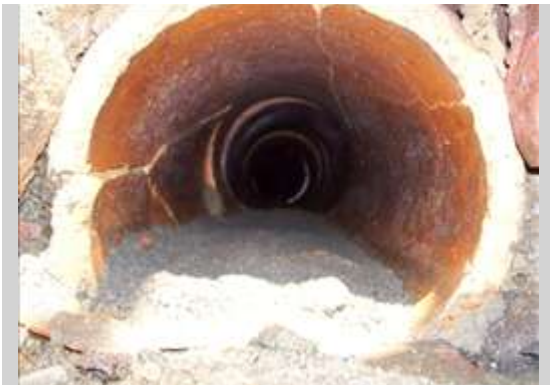
6 O'Clock Outflow

PIPE CRACKED BACK TO THE SERVICE

Deposits: ☐ None ☐ Mud ☐ Sludge ☒ **Debris** ☐ Grease

Silt Depth: **2** (in.) Deposits Extent: **Medium**

Infiltration: **None** Pipe Seal Cond: **Broken**
